# ALASKA WATER TREATMENT PLANT

## Case Study

### ALASKA WTP TAKES CONTROL OF WATER QUALITY WITH UV254

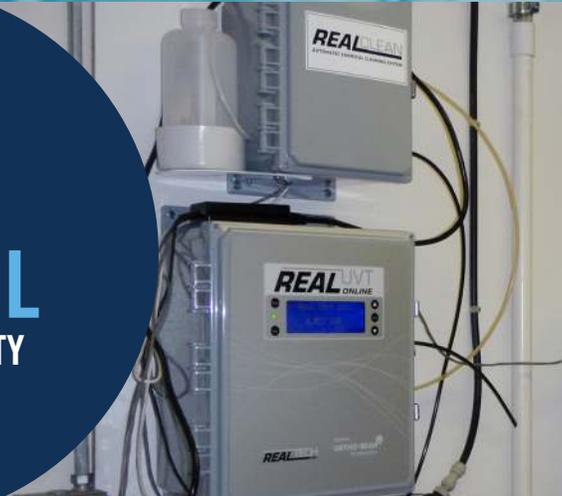
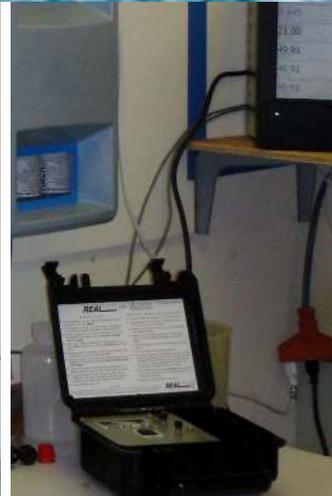
Figure 1: Real UV254 M3000 analyzer with Real Clean system installed in WTP. Real UV254 P2000 meter for grab sampling and simple custom calibration of M3000.

With the introduction of the Real UV254 M3000, the plant operator was able to monitor fluctuations in NOM coming into the plant and adjust coagulant dose accordingly. Raw water UV absorbance (UVA) values coming into the plant were in the range of 0.080-0.635 UVA. By using UV254, the plant was able to predict and optimize the coagulation process and routinely increase the effective organics removal rate, as measured by UVA, to approximately 90%. Compared to previous results, this represents a significant improvement. Since installing Real Tech Inc.'s M3000, the plant has been able to significantly reduce their coagulant costs over time while maintaining finished drinking water with UV254 absorbance in the range of 0.050-0.012 UVA which is considered extremely good quality.
