LOS FILTROS WATER TREATMENT PLANT

Case Study

**PUERTO RICO WTP
SAVES
THOUSANDS
USING REAL UV254
ANALYZER**

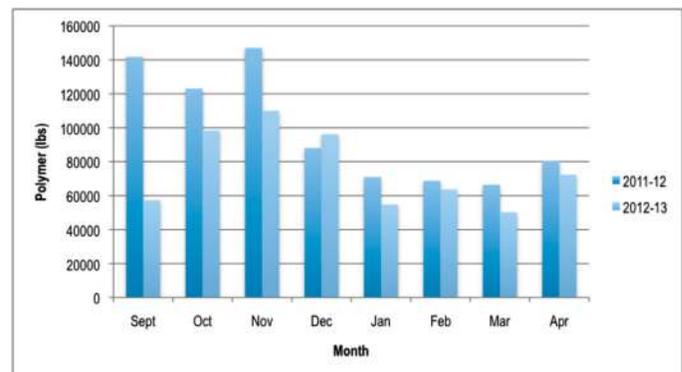
Figure 2: Monthly polymer consumption (in pounds, lbs) comparison of September 2011-April 2012 to Sept 2012-April 2013.

Results from the UV254 monitoring and dosing control package were greater than expected. Data collected from an eight-month period of continuous operation was compared against the corresponding months from the previous calendar year. Comparison of monthly polymer consumption in pounds is displayed in Figure 1. On average the plant experienced a 22,917 lbs reduction in chemical coagulant usage per month. This equated to a decrease of 23%, allowing the facility to save \$9,831 USD on average per month as shown in Figure 2. As a result of optimizing the chemical coagulant dosage, the facility also realized a reduction in filter bed backwash cycles of 23%. A decrease in backwash frequency meant more water in the system for production. Additionally, a significant 23% reduction was seen in sludge formation which in turn decreased removal costs. Beyond the cost savings and optimization, the facility remains in compliance, meeting the required TOC removal and improving DBP control.

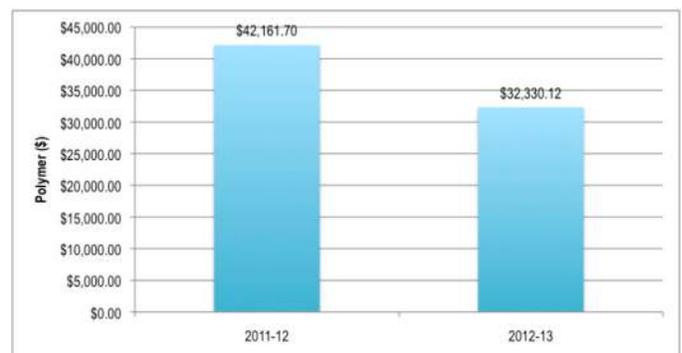
Figure 1: Average monthly cost (in dollars, \$) of polymer for September 2011-April 2012
