# IRELAND WATER TREATMENT PLANTS

## Case Study

## IMPROVING PROCESS CONTROL BY MONITORING ORGANICS IN SOURCE WATER

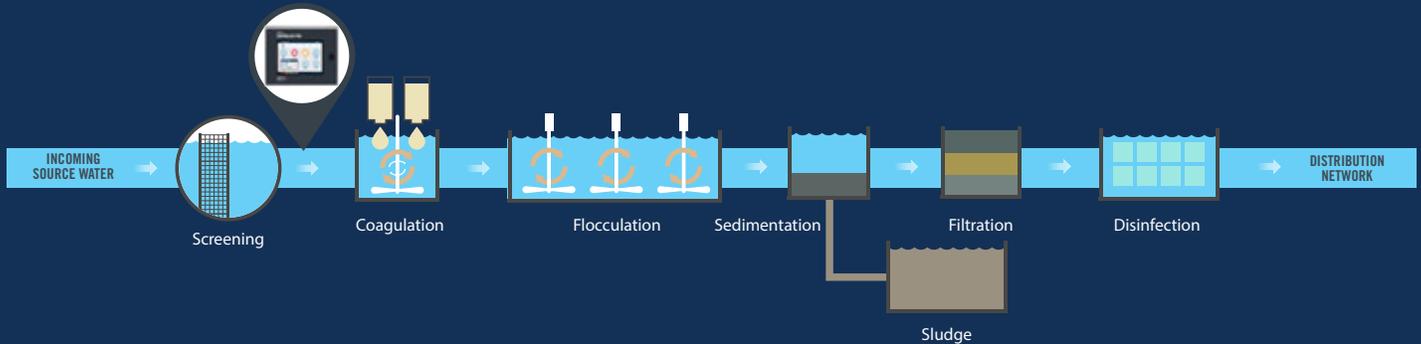
Figure 2: The typical installation point for raw water quality monitoring at a conventional drinking water treatment plant. Real Tech's dual feed upgrade allows for monitoring at two locations within the plant with a single UV254 analyzer.

Prior to installation of Real Tech's UV254 analyzers, many of the drinking water plants measured turbidity and colour with supplemental grab sampling for organics in raw water. Rapid changes are often not captured or assessed adequately with grab sampling, therefore continuous organics monitoring that would produce data at a greater frequency was essential. The UV254 analyzers provide various benefits to the treatment plants including raw water event monitoring and aiding with control of the coagulation process to enhance or optimize organics removal. Reducing the concentration of organics helps to limit DBP formation and increases disinfection efficiency, particularly for UV disinfection systems.

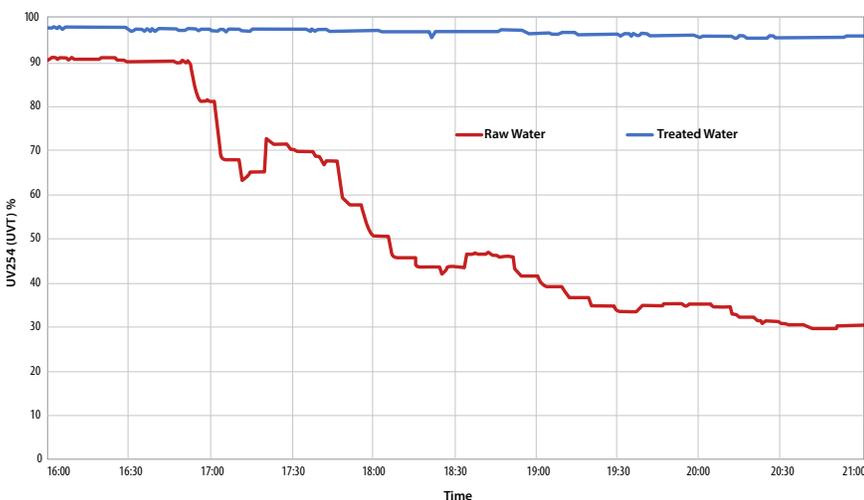
Figure 3: Data from Real Tech's dual feed UV254 analyzer. UV transmittance (UVT%) readings from raw water (red) compared to treated water (blue) visualize treatment efficiency for operators.

Specific data sets were established for varying raw water UV254 and coagulant dose rates. This UV254 to coagulant correlation data set was input into the coagulation controller to allow for predictive automated dosing of coagulant in response to varying raw water conditions. Figure 3 shows measurement from Real Tech's UV254 analyzer with dual feed upgrade that displays rapid water quality deterioration in red with consistent finished water quality in blue.

The automated system, driven by real-time UV254 data, consistently produced high quality treated water throughout raw water events with little manual intervention required. In addition, the system reduces coagulant dose rate as raw water quality improves, thus saving operational costs on chemicals.
